GMRT Central AC plant heat load capacity Test

Objective: To check the feasibility of central AC plant capacity for additional Correlator load.

GMRT Central A C plant Heat Load Capacity Test

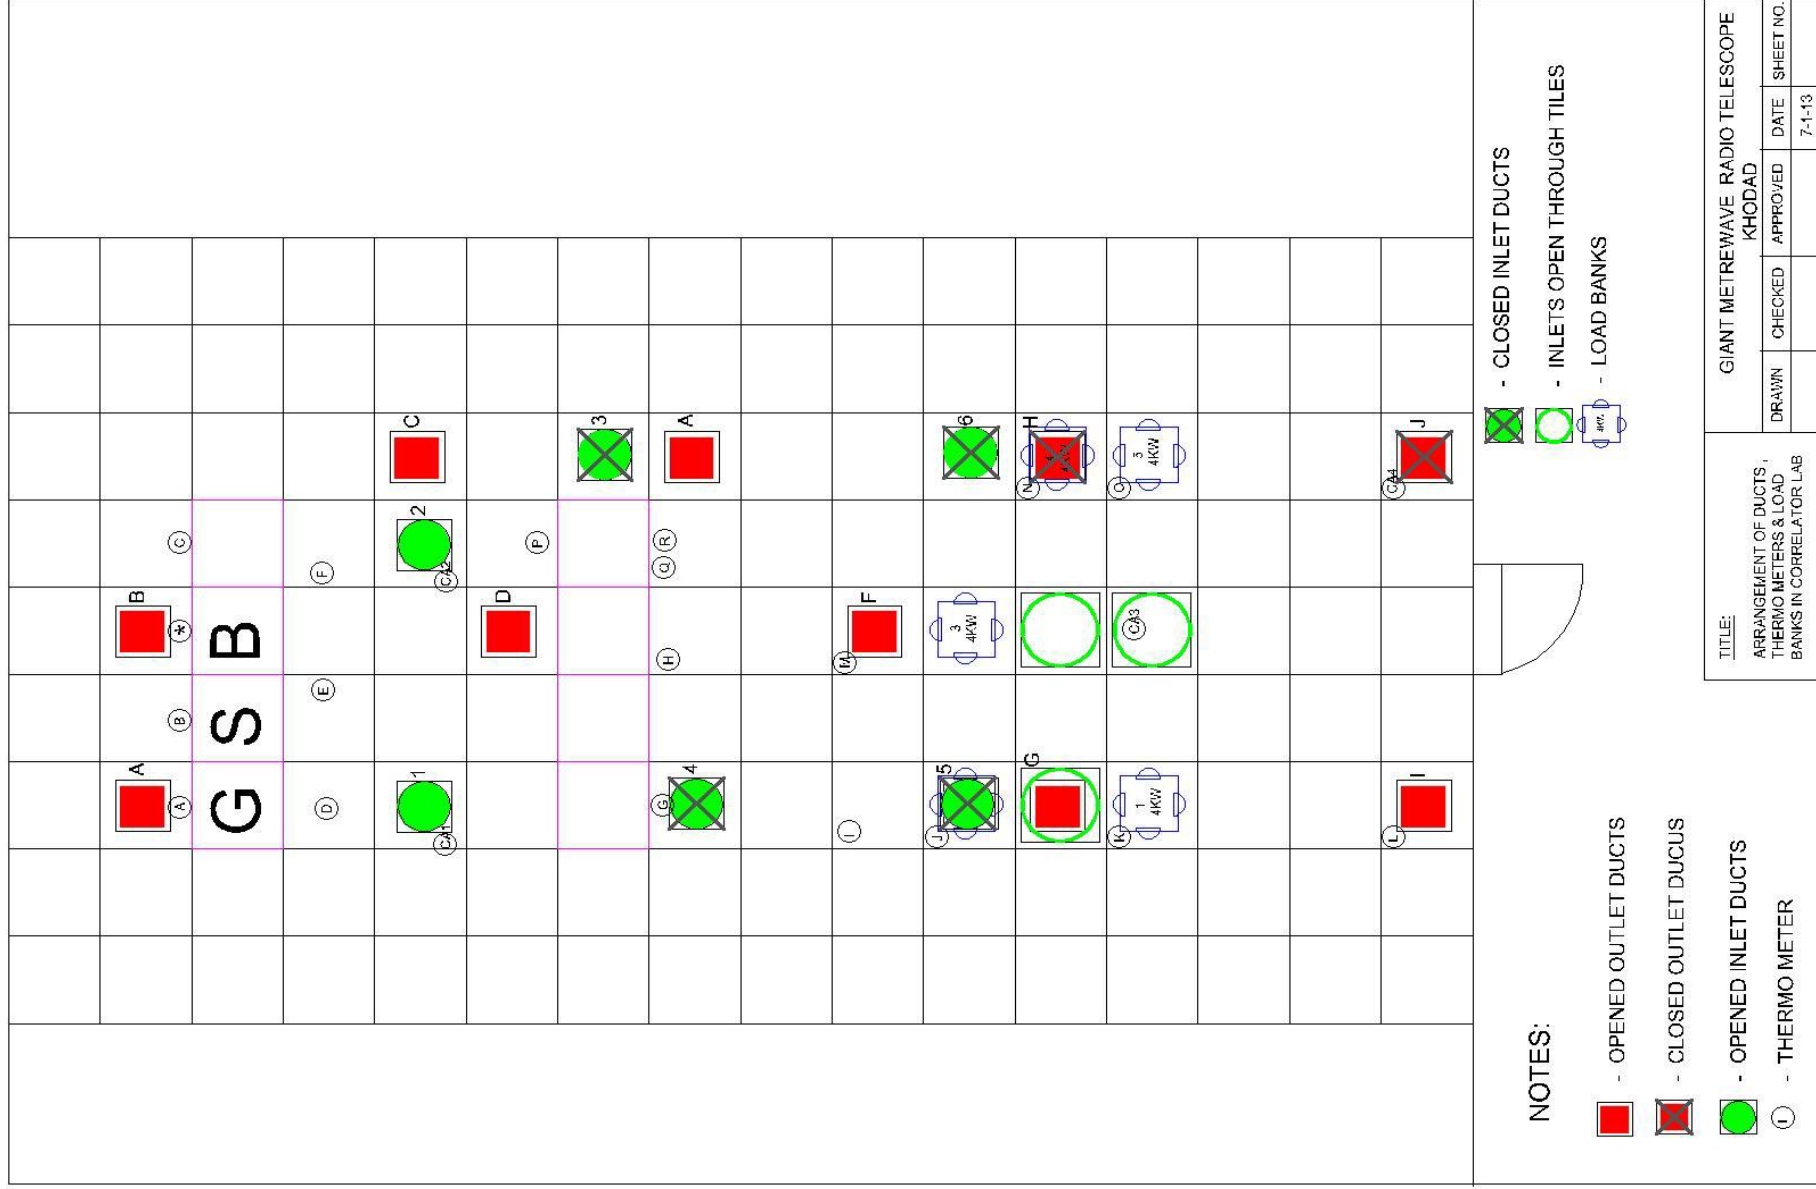
Drawing for 7th Jan testing

- Thermometers were fixed at following locations like; heat load locations, out let grills in roof, inlet grills/ dummy opening of tiles in false flooring and various locations in Correlator room as shown in drawing. AHU room return air and supply air (in front of coil and canvas)temp were measured at every 15 min interval .

Locations of thermometers are shown on drawing starting from backside of GSB rack, Temp of Supply air & return air grills were also recorded.

- Inlet and outlet grills were opened as shown in drawing to avoid short cycling of conditioned air.
- Maintained temp @ 25 deg behind GSB rack for total test period.

- 90% Ducts for Receiver room were closed still Rx room temp was at 14 deg. for entire test period.
- In corr room inlet ducts in front of GSB were opened and near Heat load area indirect supply air was taken out by opening false flooring tiles (3 tiles were opened as shown in drg.), still GSB temp did not get disturb.
